Ultrasonic Guided Wave Technology for Non-Invasive
Assessment of Corrosion-Induced Damage in Piping for Pollution
Prevention in DoD Fuel Storage Facilities

ESTCP Project WP-200819

AUGUST 2011

John M. Liu
Carrie E. Davis
Naval Surface Warfare Center Carderock Div.

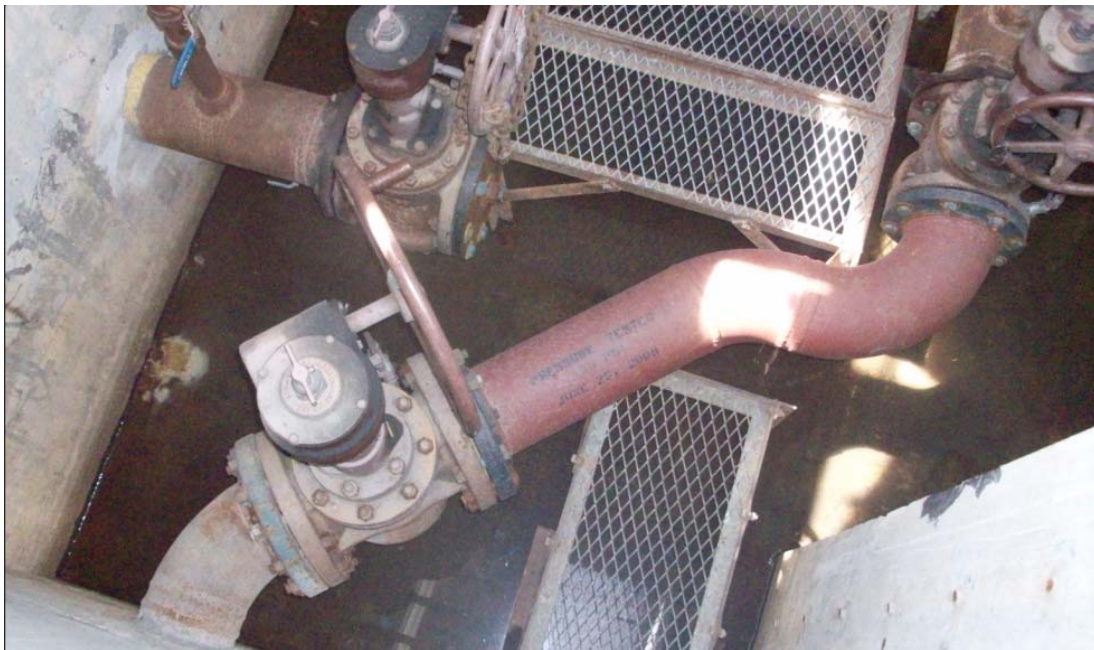
Figure 6. Pipeline accessories inside a valve pit. A section of the pipeline between Block 20 and Valve Pit 21 was replaced 4-years ago because of structural weakness as revealed by pressure testing. It has a mixture of 10 inch and 6 inch pipes connected through reducers and valves.

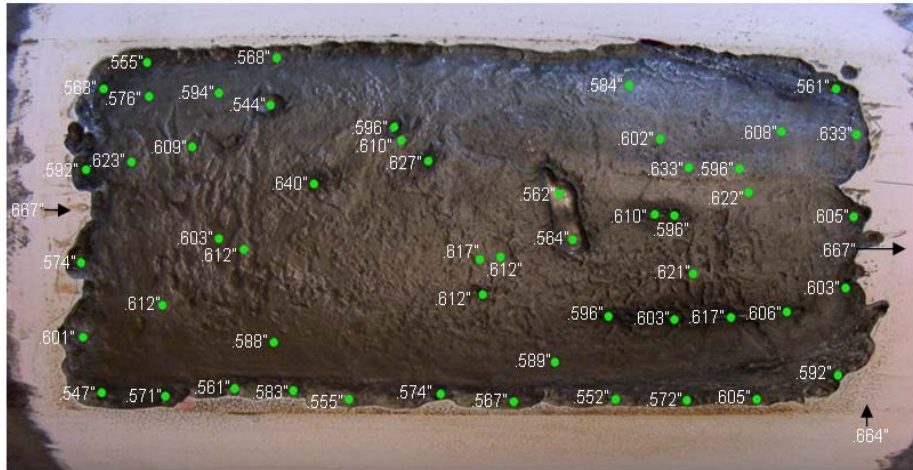
Figure 16. Annotated photograph of the Defect 1 corrosion area in Phase I.

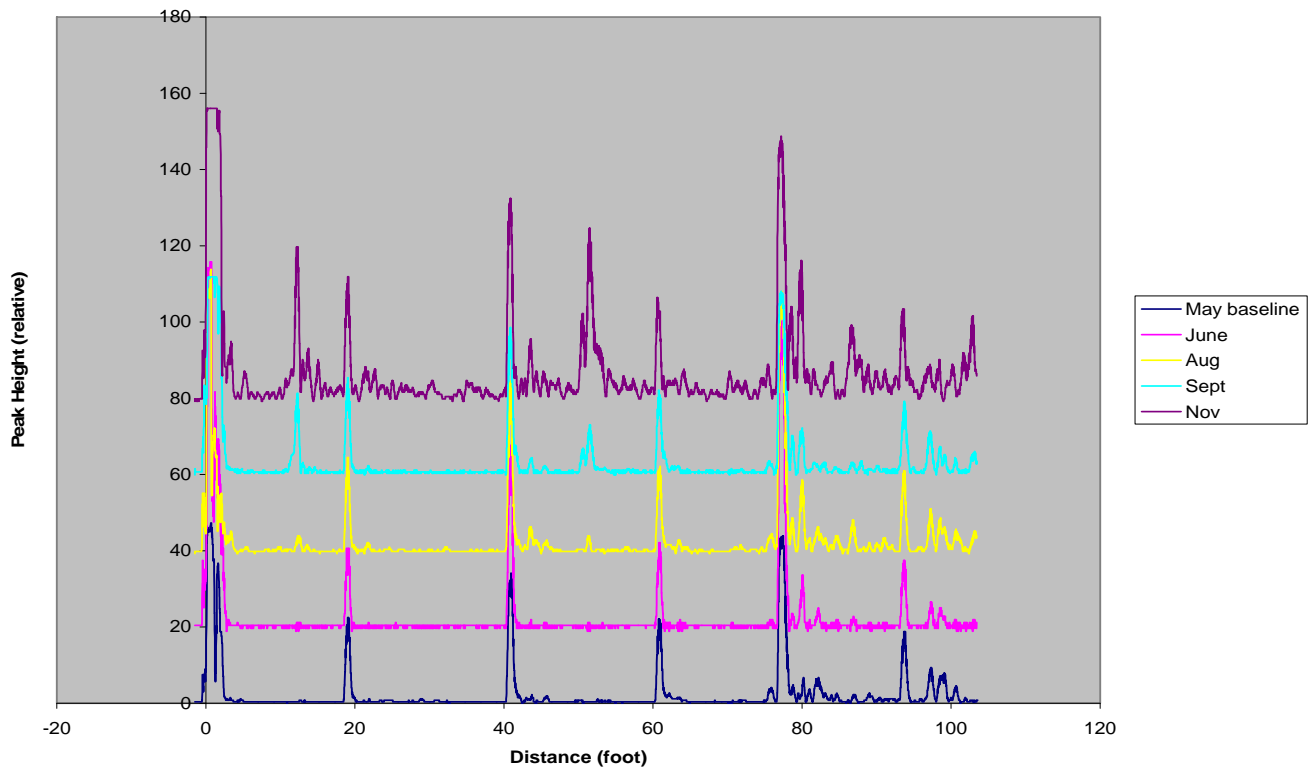
Shown in Figure 18 is the summary of the above-ground ultrasonic wave data over time as compared to the baseline with a systematic increase in defect peak height with successive stages of corrosion from a transducer placed at location 2. Waves from one transducer detect the presence of welds, elbows, and one or more defects in the guided wave propagation path. As expected, the signal height depends on the size of the defect, the distance between the transducer and the defect, and the number of welds in the wave propagation path. We note that the noise level increased in the later months as corrosion progressed, but was less than 0.1 of the weld signal height at about 80 feet.

Figure 18. Systematic increases in defect detection over time as compared to the baseline. Systematic increases in peak heights for growing Defects 1 and 2 sensed by transducer at location 2. Defect 1 was located at approximately 50 feet and Defect 2 was located at approximately 12 feet. The other large peaks, approximately 20 feet apart, are from the welds in the pipeline. The baseline signal (May 2008) is blue, the June signal is pink, the August signal is yellow, the September signal is light blue, and the November signal is purple. An offset of twenty units along the vertical axis has been added to each successive trace before plotting.

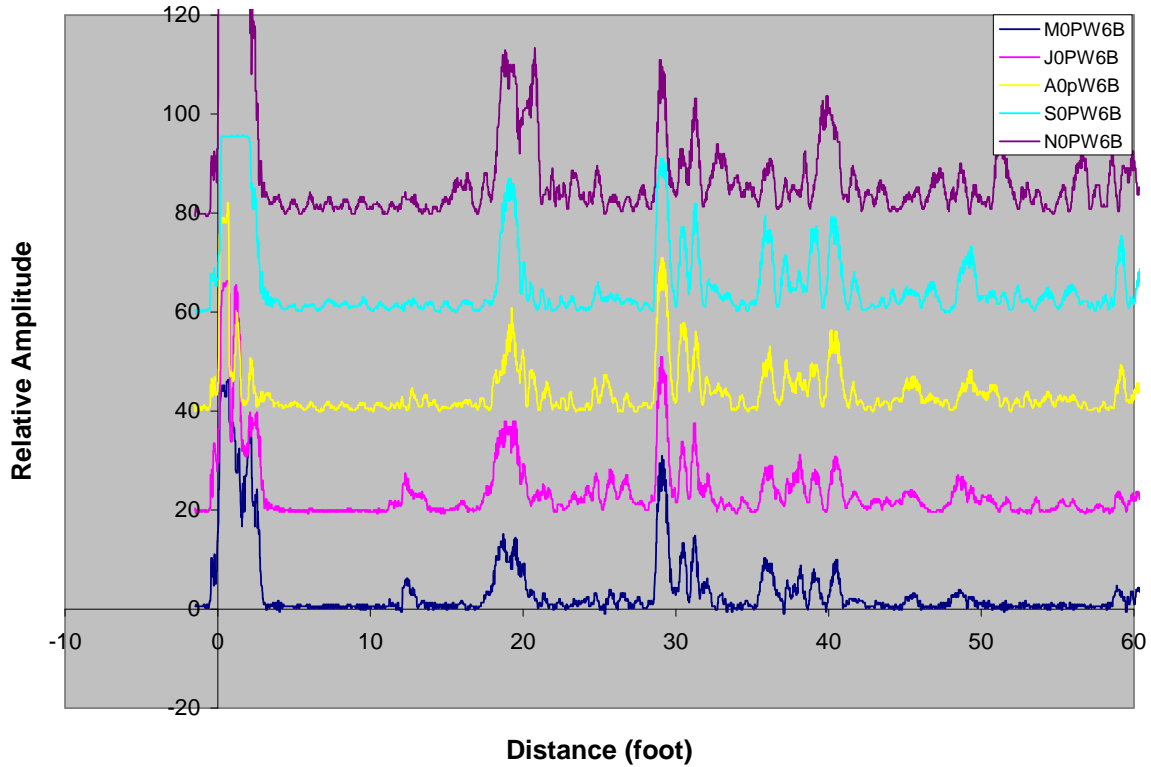
Figure 19. Systematic increases in weld defect detection over time as compared to the baseline. The transducer was at location 0, launching waves toward Defect W6. The baseline signal is blue, the June signal is pink, the August signal is yellow, the September signal is light blue, and the November signal is purple. Note the “split peak” feature associated with the corrosion around the weld. An offset of twenty units along the vertical axis has been added to each successive trace before plotting.

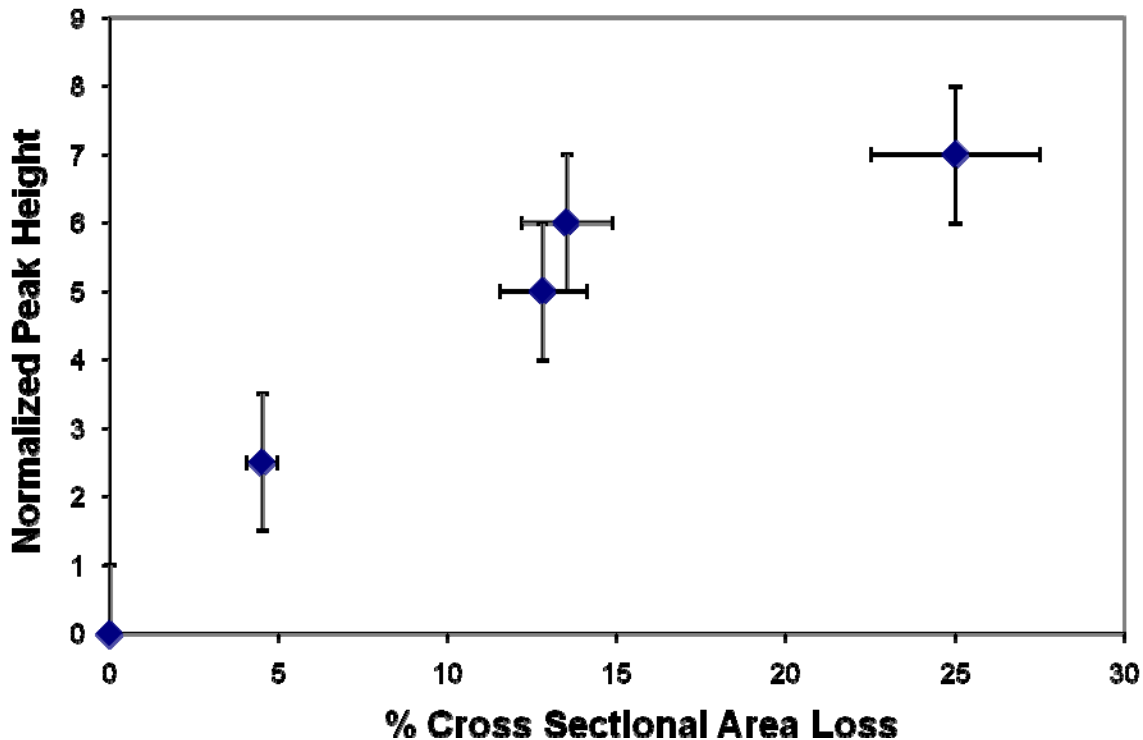
Figure 23. Plot of signal height against defect CSAL for defect W6 showing increased signal peak height for the weld signal as corrosion increased.

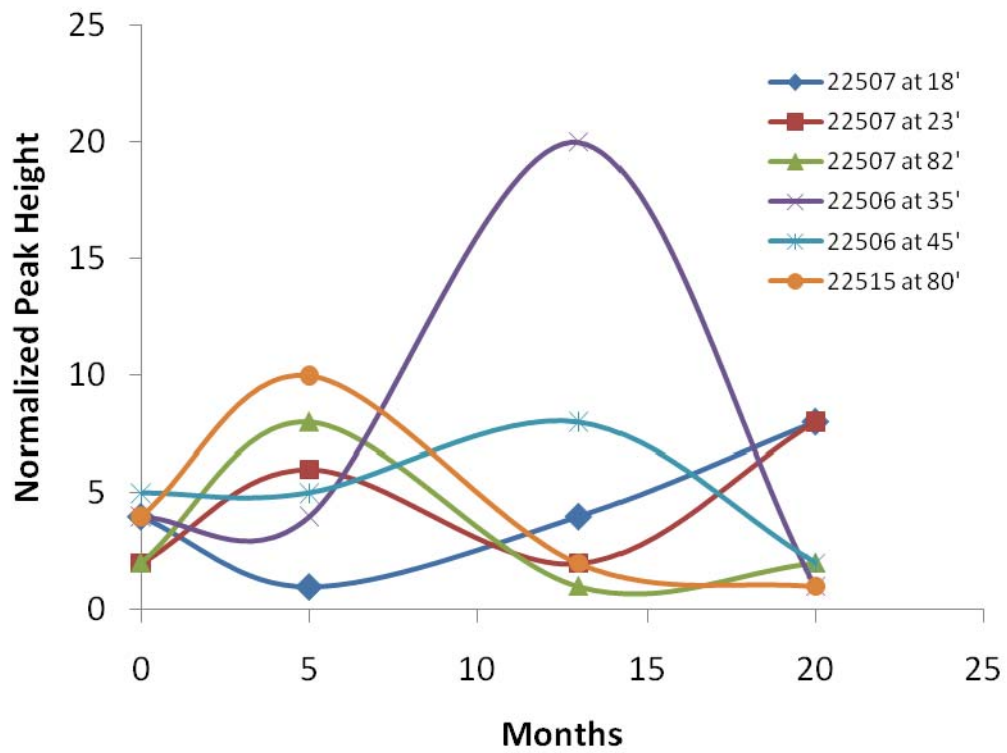
Figure 36. Changes in normalized peak height at suspected defect locations detected by three above-ground transducers.
Typical signal noise was 2 vertical units.

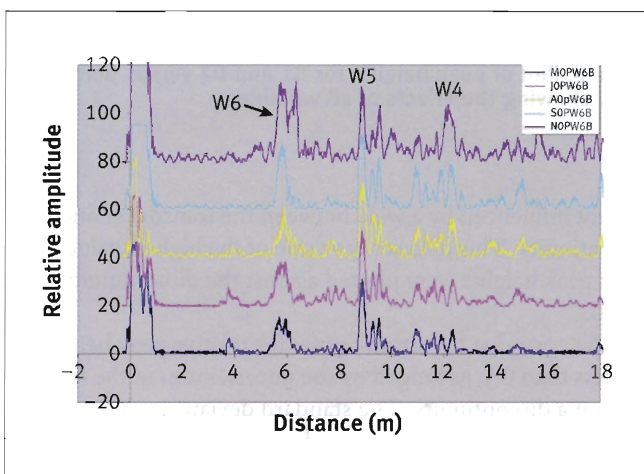
Figure 5. Data traces showing the increase in peak height and split peak features at W6 located approximately 5.5 m from the transducer placed at Location 0. An offset of 20 units along the vertical axis was added to each successive trace in this Figure.
